# Performance of Structural Liners at Locations of Ring Fracture when Subjected to Bending, Axial or Shear Loads.

Trenchless Technology Center

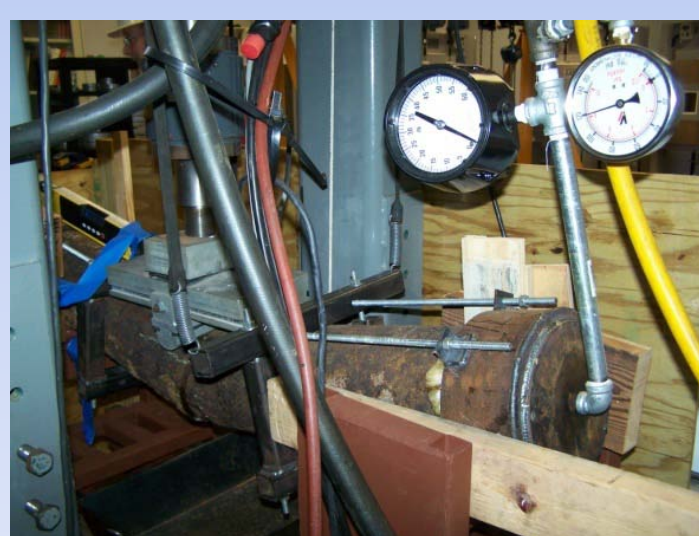
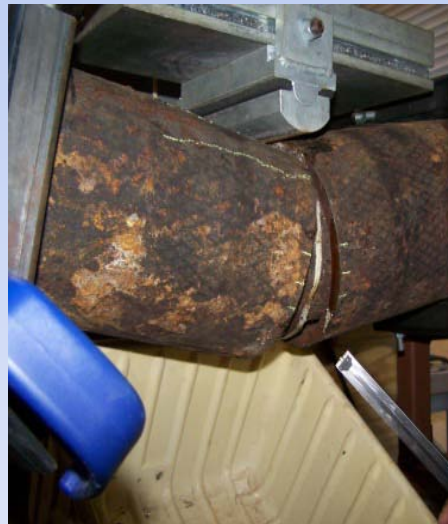
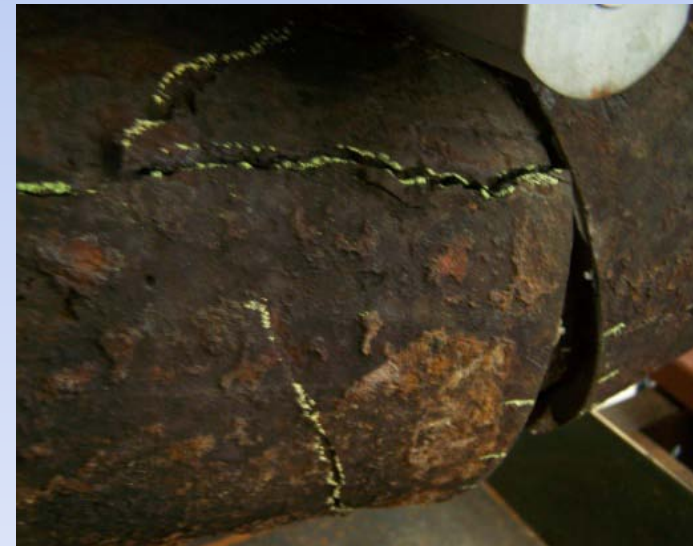
- Host pipe crushed at the crown at a vertical displacement of 4.5”.
- At a vertical deflection of 5” the liner was holding 120 psi with little to no support from the host-pipe; no leakage was observed.

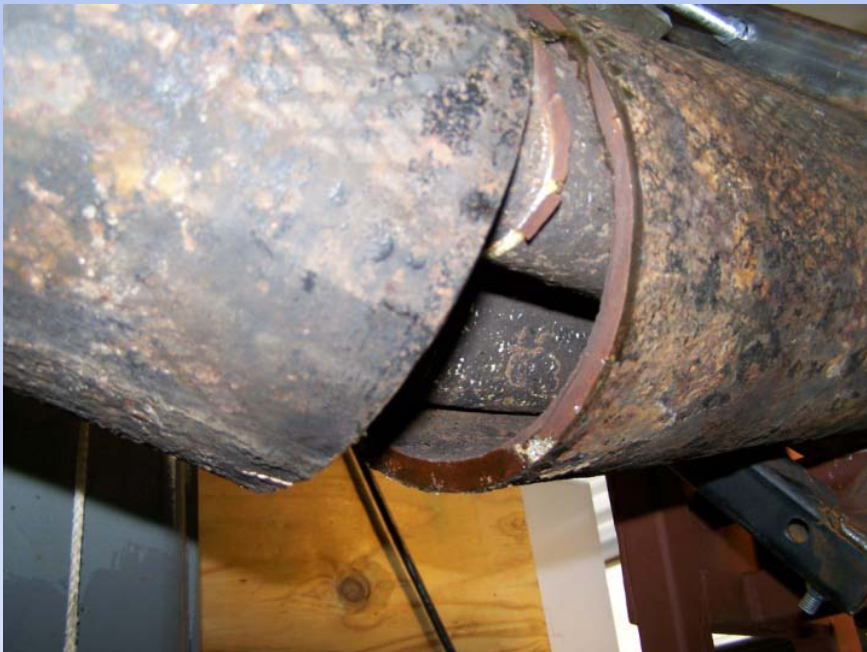
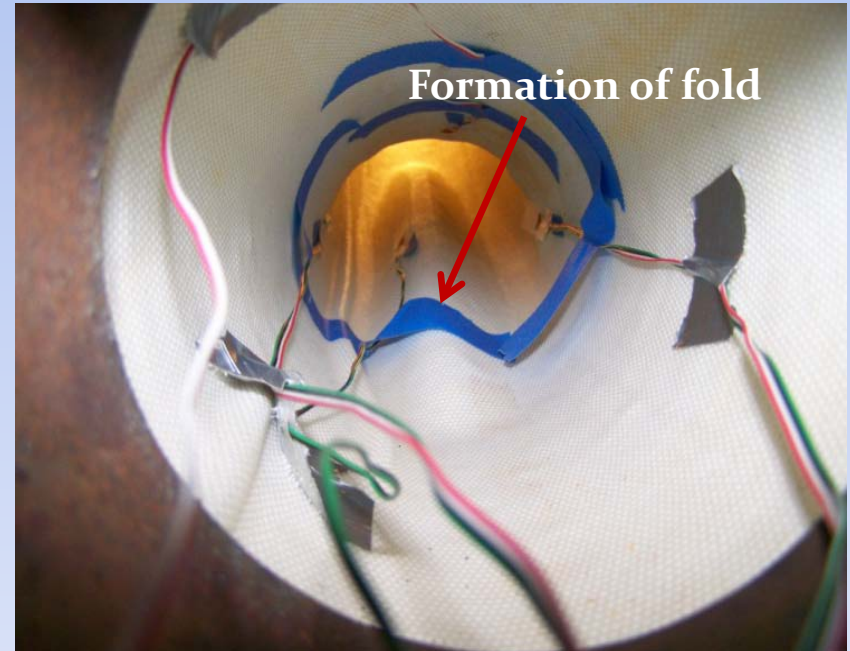
- When the displacement reached 4" (angular displacement near center of the specimens  $\sim 11^\circ$ ), a fold was formed at the invert; shortly thereafter the liner lost its structural integrity.

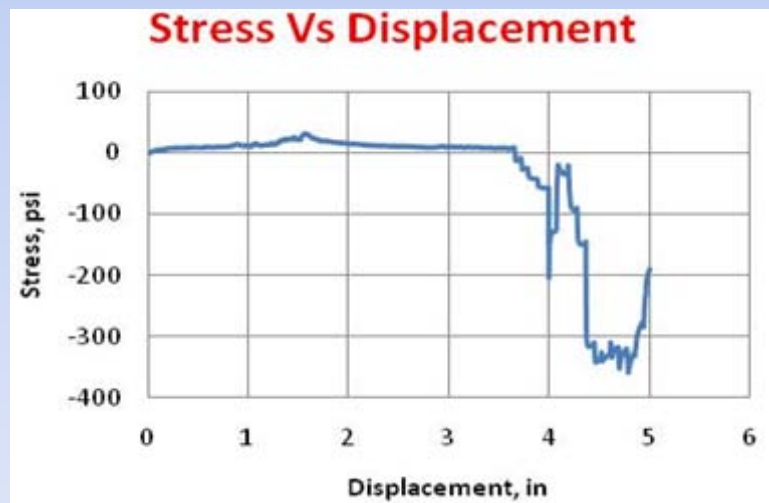
Strain gage at crown( Longitudinal)

- Responses measured by strain gauges (compression at crown & tension at invert) commenced at deflection of approx. 3.7”.
- The responses suggested de-bonding at the host pipe-liner interface and transfer of the load from the host pipe to liner at the instrumented section.

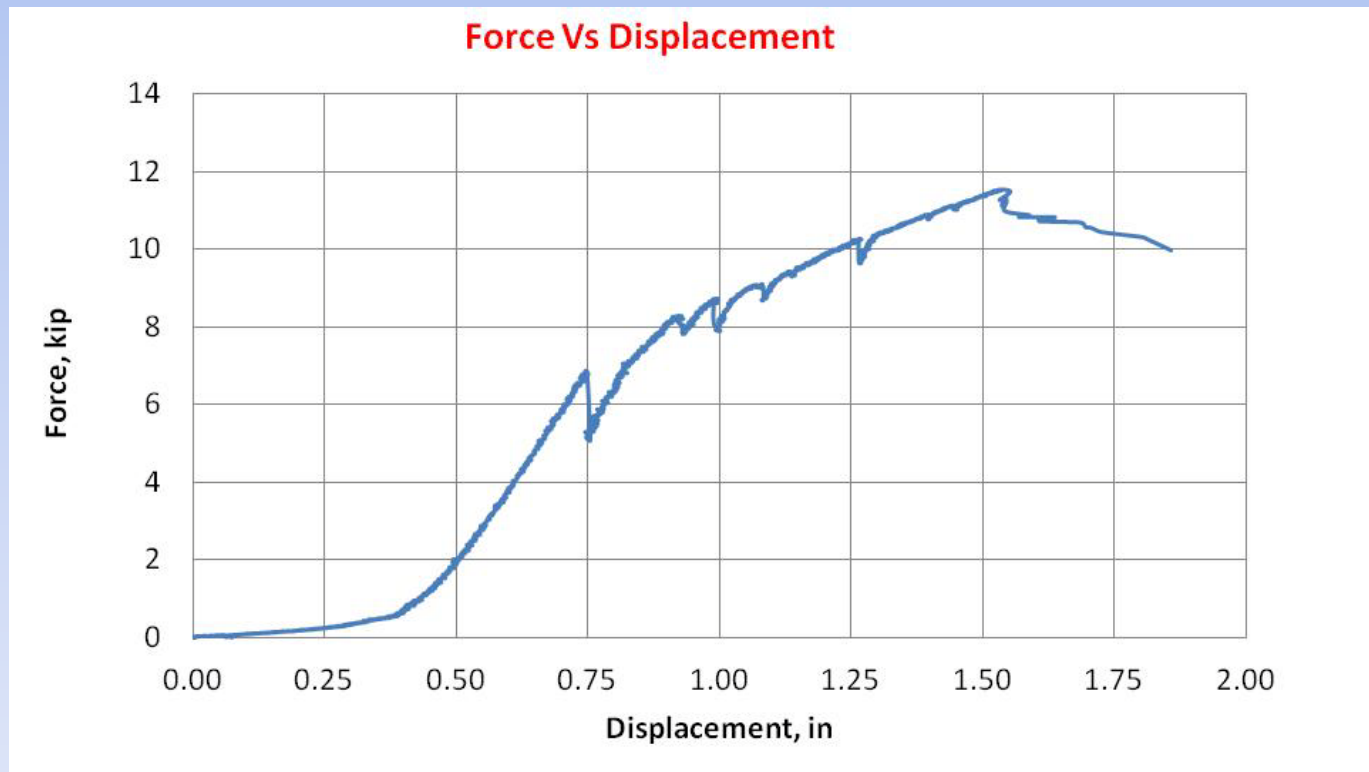
- Initial slip occurred when specimens was subjected to an tensile axial load of 7 kip.
- Steady axial movement of the liner was observed under an axial tensile load of 11.5 kip.

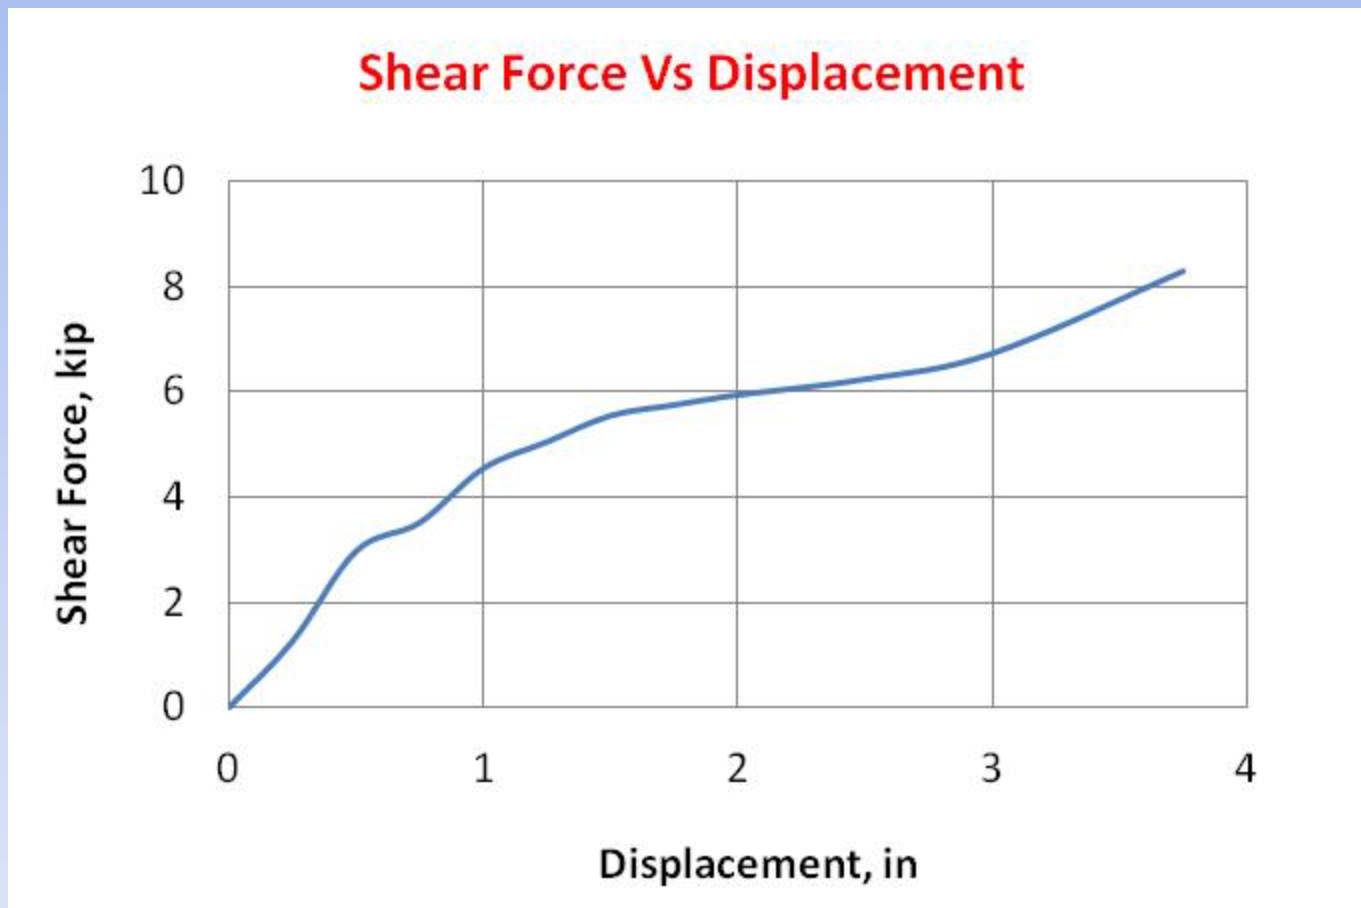
- De-bonding took place at approx. 3.5 kip.

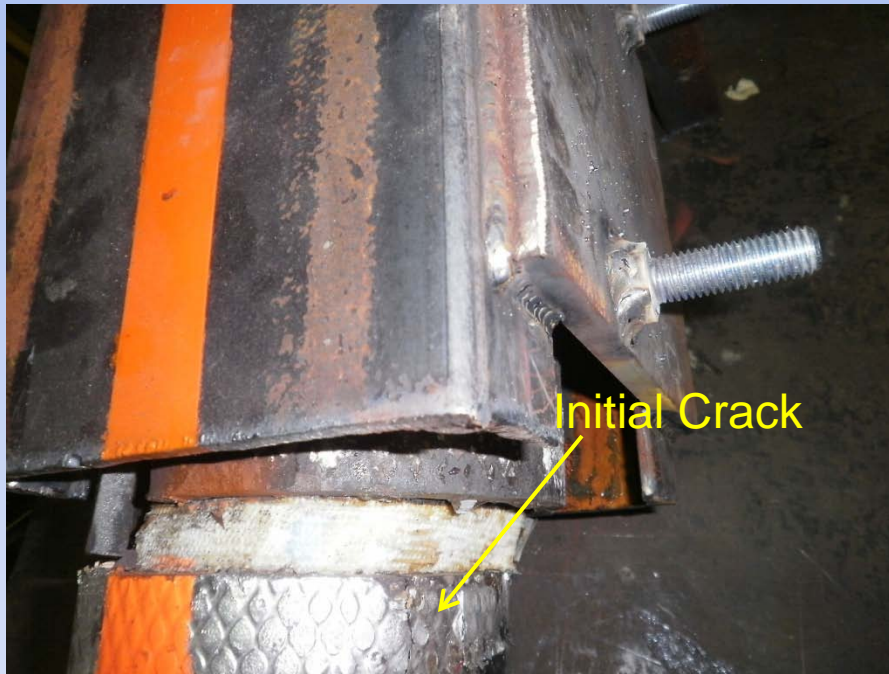
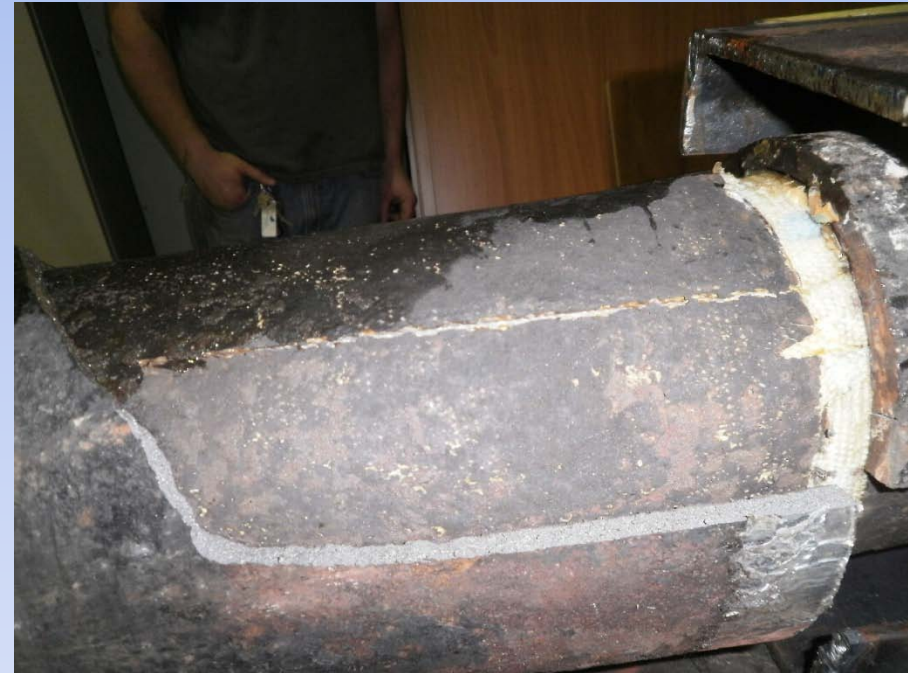
- After each increment (0.25”) of pushing, the internal pressure was increased to 60 psi.
- Initial crack occurred at the spring line at fixed half of the host pipe opposite the actuator.
- Major crack occurred at crown of host-pipe on (*loaded section*).
- The liner cracked at a lateral displacement of 3.5” under 100 psi internal pressure; failure took place in the form of a rapture around the circumference of the liner.

Complete Failure of Host-pipe

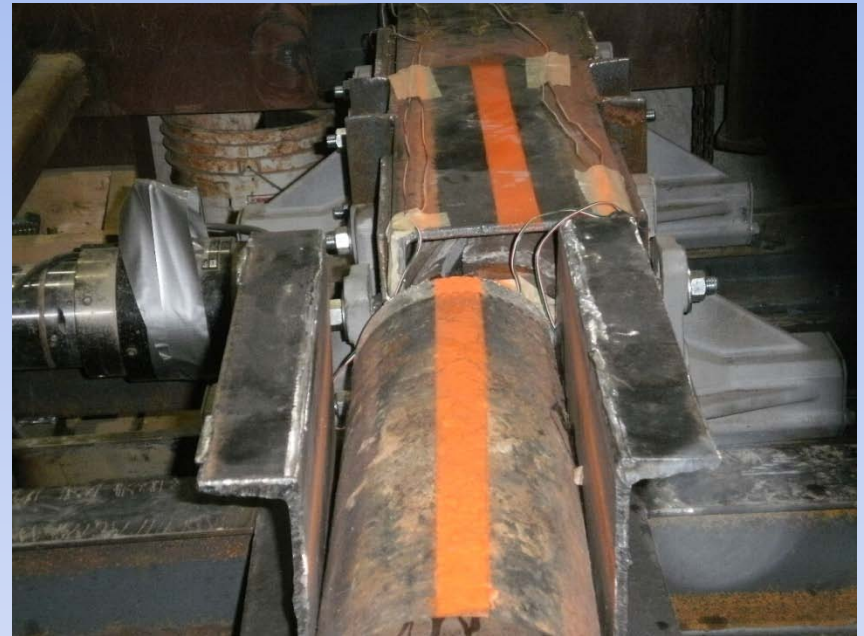
Liner failure at  
displacement of 3.50in
