Trenchless Technology Center  
Louisiana Tech University

## Experimental Evaluation of Selected Limit States of Aqua-Pipe<sup>®</sup> Liner at Locations of Ring Fracture

Erez N. Allouche, PhD, P.Eng.  
Shaurav Alam, Ph.D.

**April 11, 2012**

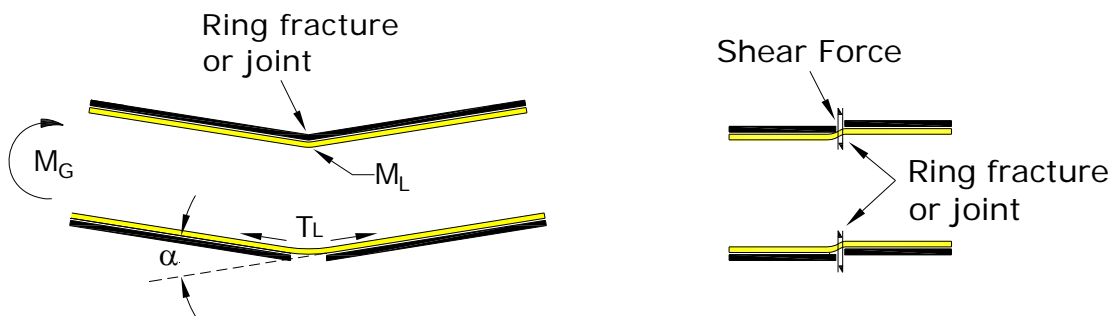
Figure 1: Forces resulted from bending and shear movement of the host-pipe

This experimental research focuses on the behavior of the Aqua-Pipe® Liner subjected to bending, shear, and tension under both pressurized and non-pressurized conditions at the location of the ring fracture. Figure 1 and Figure 2 shows the qualitative consequence of flexure, shear, and tensile forces on the liner caused by differential movement of the host pipe at the location of the ring fracture.

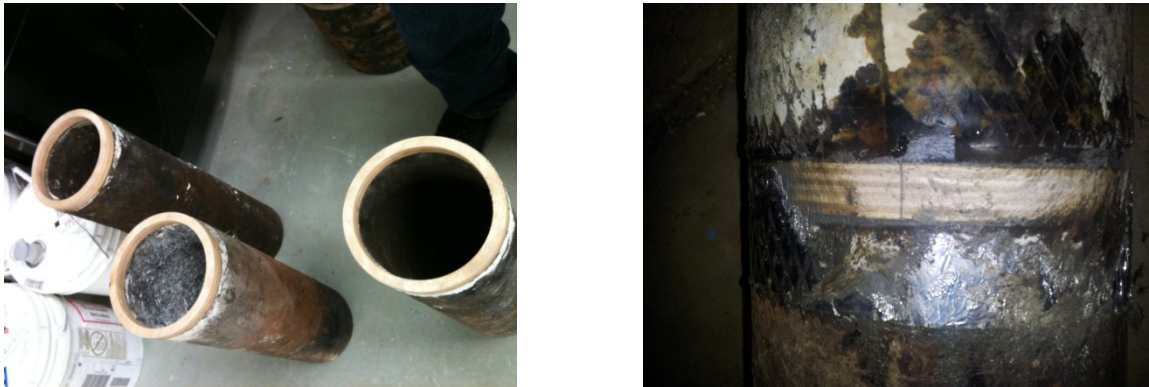
Figure 3: Location of wooden spacer (left) and wooden spacer in between the host-pipe sections (left)

Test specimens were prepared using 6 in. diameter, 4 ft. long cast iron host-pipes, which were in service for 70 years. The uneven internal surface of the host pipe supported mechanical interlock between the resin and the host pipe. First, the host-pipe was cut into two halves and a thin circular wooden spacer was placed between them. Next, a mechanical clamp was used to hold the sections contiguously and the samples were sent to Montreal, Canada, to be lined (see Figure 3). The lined specimens were shipped back to the Trenchless Technology Center, where the wooden spacer was removed to form the simulated ring fracture between the host-pipe sections (see Figure 4).

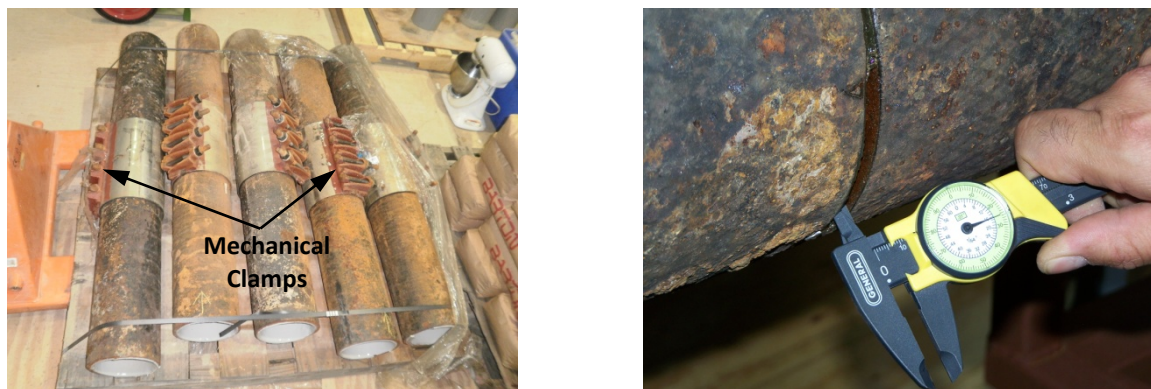
Figure 4: Specimens after lining (left); host-pipe sections after removal of clamps and spacer (right)

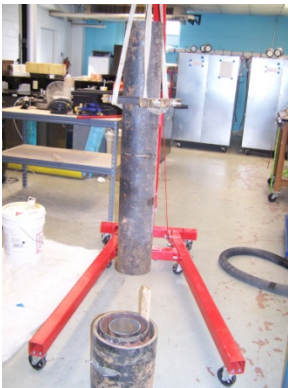
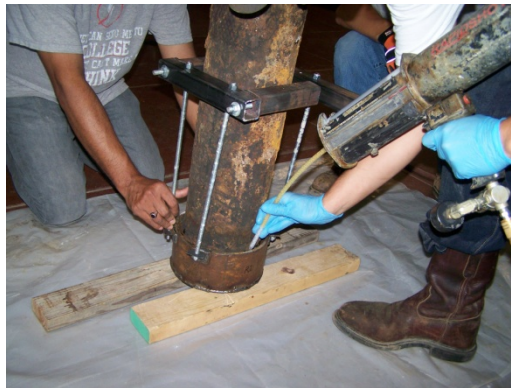
Figure 6: Test specimen hung over the cap (left), application of polyurea (middle) and final setup (right)

The annulus between the caps and the specimen's wall was sealed using polyurea (Part A + B organic compound with rapid setting time), making the specimens leak proof (see Figure 6).

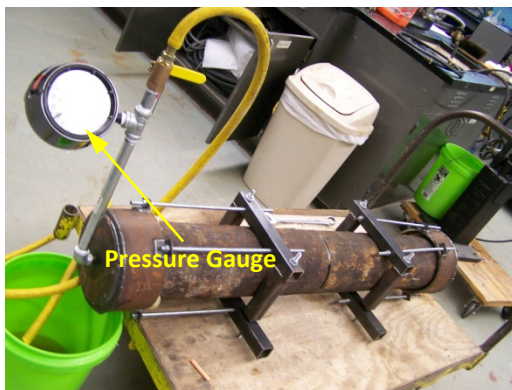
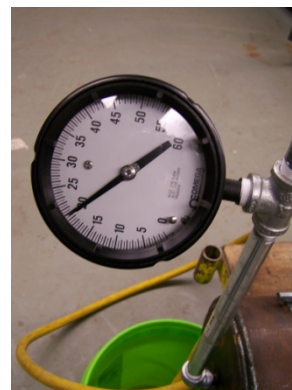
Figure 7: Pressurized leak test performed on the test specimen

A leak test was performed using a high pressure pump to test the polyurea seal prior to commencement of the actual test. The pressure was held at 20 psi for about 30 minutes to confirm a tight seal at the edges of the capped specimen (see Figure 7).

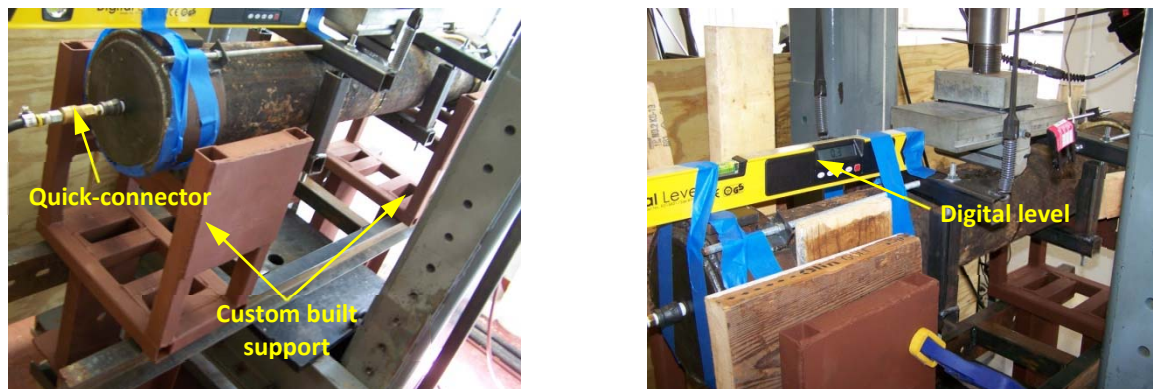
Figure 8: Host pipe placed on custom built support (left) and deflection measurements (right)

The capped test specimen was placed on two custom built supports for the bending test. Wooden planks were used to restrict the rotation of the test specimen about its neutral axis. A digital spirit level was attached at the crown of the host-pipe to measure angular displacement of the specimen throughout the test. As the host pipe was noncontiguous at its center, a hinge condition was developed at that location of the pipe under the applied external load as shown in Figure 8.

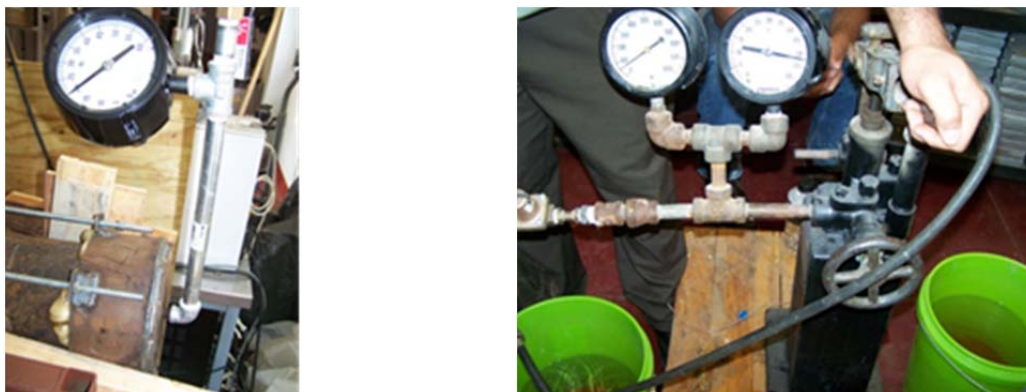
Figure 9: Pressure gauge (left) and manually operated pressure pump with pressure regulator (right)

During the pressurized experiment, the internal pressure within the specimen was monitored at all times using a pressure gauge. A pressure regulator was used to restrict the applied internal pressure to a maximum of 120 psi (see Figure 9). A 50 kip MTS servo-controlled actuator was used to apply a point load to the location of the ring fracture (3-point load loading configuration), resulting in a vertical deflection at the invert of the cast iron host pipe to increase 0 in. to approximately 5 in. in increments of 0.25 in., corresponding to an angular displacement of about  $12.5^\circ$ . The angular displacement was read using the digital level. Table 1 provides a summary of the geometrical changes observed for the host pipe and liner with an increased vertical deflection.

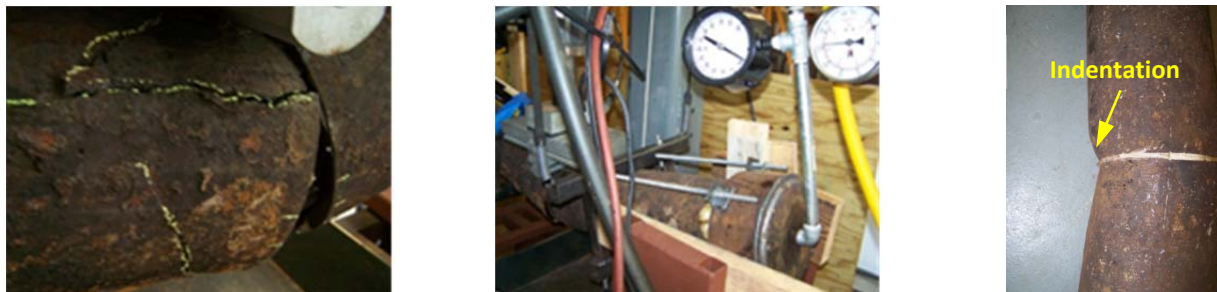
Figure 11: Crushed host-pipe (left); deflected liner holding 120 psi internal pressure (middle); deformation at the liner's crown region (right)

At a vertical displacement of 4.0 in. with 60 psi internal pressure, the liner began to protrude. The host-pipe crushed at a vertical displacement of 4.5 in; however, at a vertical displacement of 5 in., the liner was still holding 120 psi with no visible sign of failure of the liner. The test was terminated at this point and the liner was removed from the host pipe. An image of the liner following the test is given in Figure 11. The host-pipe cracked and the liner deformed at the crown at the location of the externally applied load.

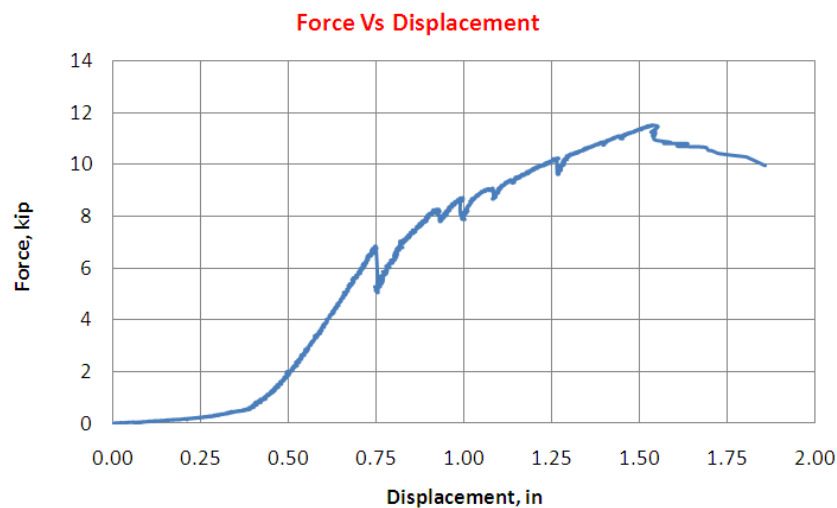
Figure 17: Pulling force vs. displacement

The tensile uni-axial test was performed under non-pressurized conditions. One end of the capped specimen was held in place by a specially built frame, while the other end was connected to a 150,000 lb servo-control hydraulic actuator via a swivel connection. Two parabolic-shaped cut rods forming an umbrella skeleton were welded to each cap. Next, the actuator was pulled at a rate of 0.12 in/min until the host-pipe was observed slipping out of the liner at the location of the ring fracture. The average thickness of the pipe and the liner were measured to be 0.554 in. and 0.182 in., respectively. Based on a contact length of 48.0 in. and an outer diameter of 6.95-in., the total contact area between the liner and host-pipe were found to be 881 in<sup>2</sup>. A pullout force of 11.5 kip (see Figure 17) was needed to overcome the friction between the liner and the host pipe (i.e., mobilize the liner), representing a friction value of approximately 13 psi (or 1800 lbf per square foot).

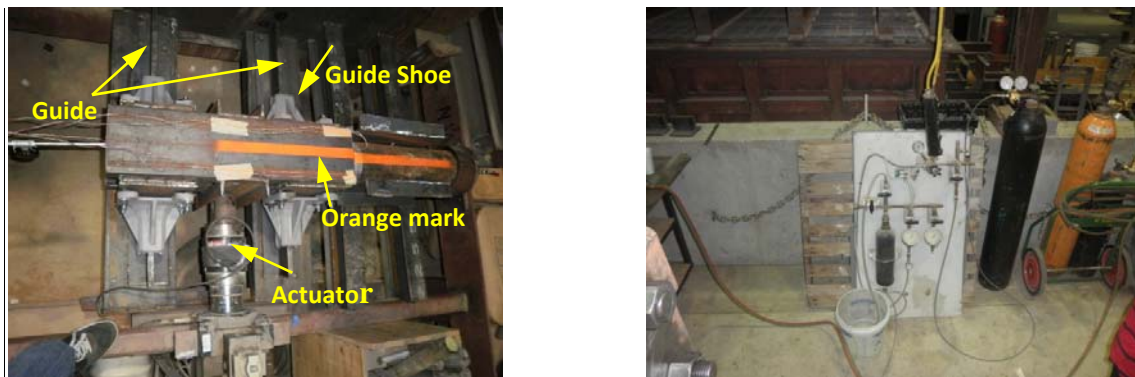
Figure 18: Experimental setup of the shear test (left) and the nitrogen gas operated pressure pump (right)

For the pressurized condition test, the specimen was prepared following the same procedure as the flexure test specimen and placed carefully inside the test setup. A strip of orange paint was placed along the crown of the specimen to allow better visualization of the lateral movement across the ring fracture. A nitrogen gas operated pressure pump was used to generate internal pressure inside the pipe specimen (see Figure 18).

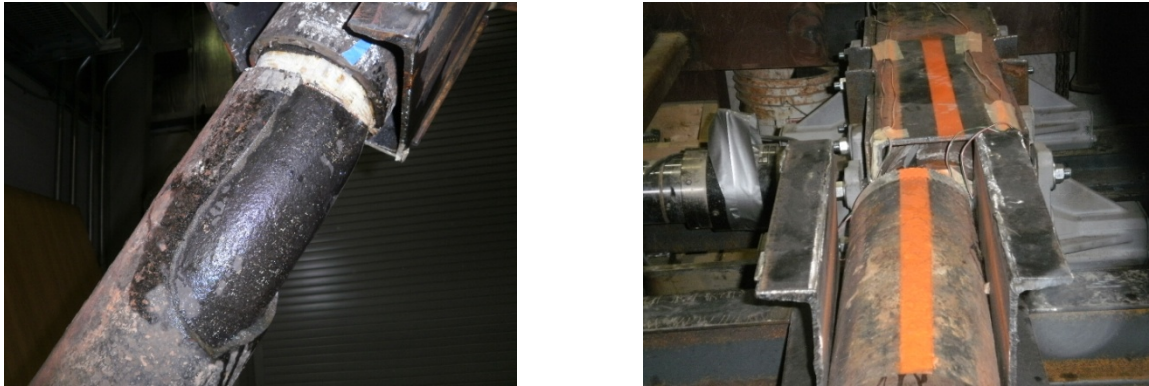
Figure 20: Host-pipe broke at crown-invert plane (left) and 3.5 in. displacement of the liner (right)

As the displacement reached 1.5 in. the host-pipe cracked at the crown-invert plane and debonded from the liner. Following the failure of the host pipe, that liner was found to be able to hold 60 psi internal pressure. The liner ruptured at a lateral displacement of 3.5 in. and an internal pressure of 100 psi (see Figure 20).

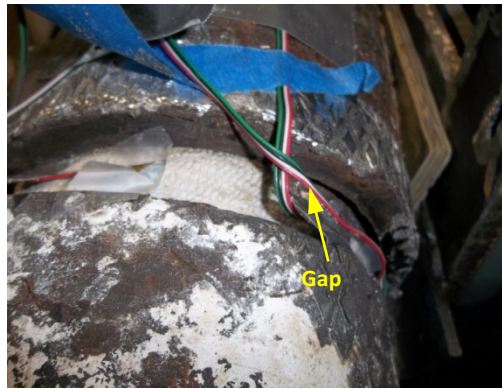
Figure 22: Strain gauge installed on the liner

Stain gauges were installed at the outer wall of the liner to obtain accurate strain measurements at the location of the ring break (see Figure 22).

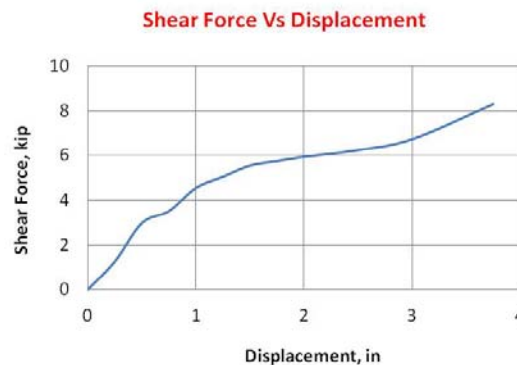
Figure 23: Response of strain rosettes at spring-line (west) (left) and at invert (right)

The liner at the displaced section de-bonded from the host-pipe at the spring line (west) when the shear displacement reached about 2 in. As the specimen was not pressurized, the gap between the inner wall of the host pipe and the outer wall of the liner increased with the increasing displacement and propagated from the spring line region (west) to the invert area. Thus, relatively low stresses developed at the spring line (west) and invert. The liner exhibited a complete de-bonding from the pipe's wall at the spring-line (West) and invert, when the shear load reached around 7 kip at a displacement of 3.5 in. (see Figure 23).
